Thermographic Study for Diagnosis and Assessment of Long Bone Fracture Healing in Dogs

Ind J Vet Sci and Biotech (2024): 10.48165/ijvsbt.20.4.16

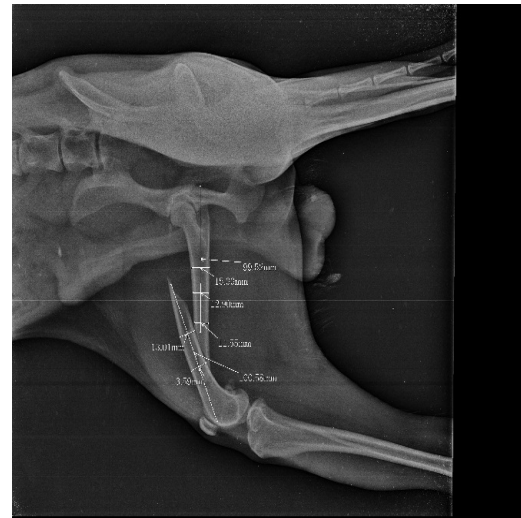
Fig. 2: Sp1: normal limb (84.2 °F), Sp2: affected limb (83.1 °F)

Pre-operatively, the temperature at fracture site from affected limbs when compared with opposite normal limb varied from 1.5 to 4.0°F. This variation depended upon injury, region of injury, severity of injury and involvement of soft tissue (Fig. 1 to 4). However, sometime temperature of normal limb was higher than affected limb due to soft tissue or crushing injury during automobile accidents, fall down or any traumatic injury of normal limb. Similarly, Strasse *et al.* (2022) assessed all patients with a bone fracture diagnosis, the average temperature of the injured limb displayed a noticeable positive deviation exceeding 33°F in comparison to the opposite side. This signified a precise identification of the site of the bone injury. Conversely, regions identified with compromised blood circulation exhibited an average temperature with a discernible negative change.

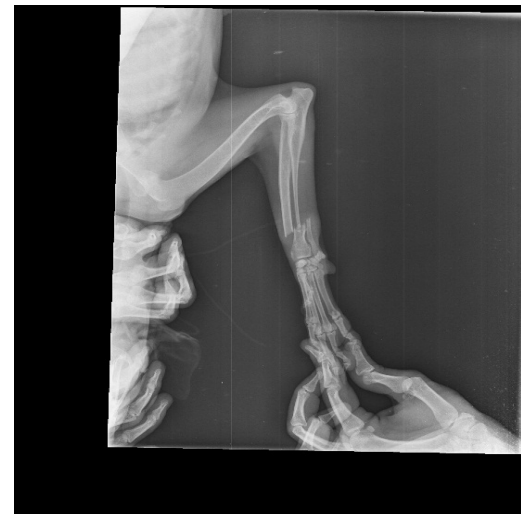
Fig. 3: Sp1: normal limb (92.1 °F), Sp2: affected limb (95.9 °F)

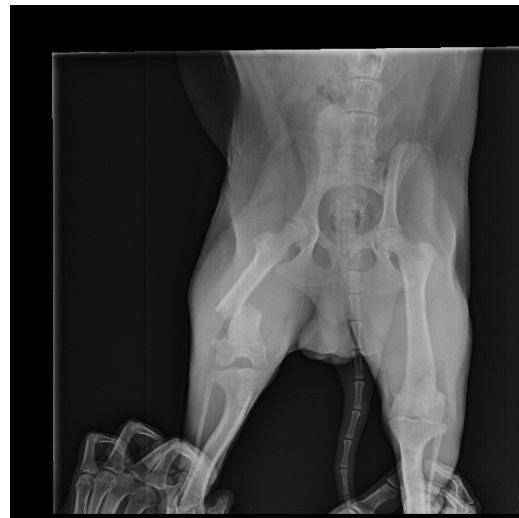
Fig. 4: Bx1: normal limb (86.4 °F), Bx2: affected limb (89.1 °F)

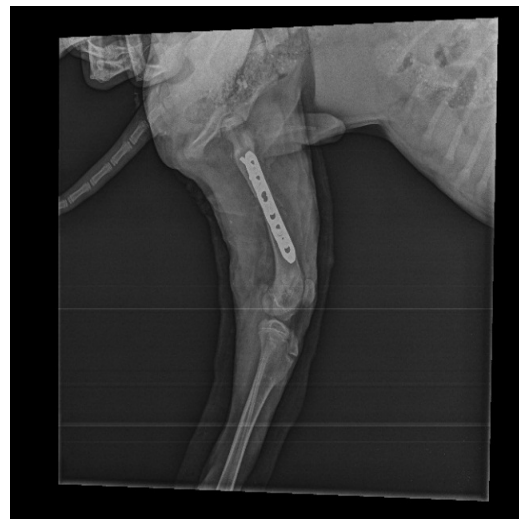
Fig. 5: Bx1 (99.1 °F) is lesser than Bx2 (100.3 °F). Bx3 is less than Bx2 (100.3 °F). Bx1: operated site, Bx2: operated site, Bx3: normal limb (15th post-operative day)

15th day post-operatively, the temperature of affected limb was higher than normal limb and also showed intense thermal pattern due to injury to soft tissue, inflammation, increased blood supply towards bone healing, manipulation of soft tissue during surgery and application of bandage. Temperature difference varied from 1.5 to 3.5°F when compared with normal or opposite site of same body parts (Fig. 5). Casas-Alvarado *et al.* (2024) opined thermography has become an assistance tool in veterinary and is used to noninvasively evaluate heat elimination during and after inflammatory processes or during the recovery period. On 30th day still there was increased temperature in affected limb as compared to normal limb, but intensity of thermal pattern was decreased as compared to 15th day observation. This might be due to reduction in inflammation related with injury of soft tissue, which was manipulated during surgery and skin wound also healed at this time. Increased temperature

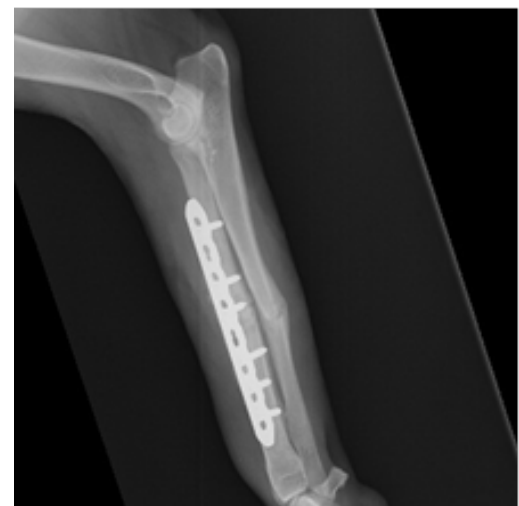
Fig. 6: Bx1 (97.1 °F) is higher than Bx2 (95.2 °F). Bx1: operated limb Bx2: normal limb (30th post-operative day)

The temperature difference varied from 1.0 to 2.5°F as compared to normal limb on day 30th (Fig. 6). Similar to this study Silvia *et al.* (2012) hypothesized that fractures would be associated with local hyperthermia, detectable with thermography which could then direct focused radiographs. Strasse *et al.* (2021) also obtained similar thermal images throughout the course of the 20 clinical assessments that enabled a connection to be established between the data derived from X-ray examinations and the opposite limb of the patient under evaluation. These images revealed thermal changes exceeding 0.3°C, which signify notable physiological irregularities. Progressively, over a period of time, temperature difference was decreased and after 2 months of injury, this difference was almost nil between opposite limb and the region of interest (ROI) (Fig. 7).

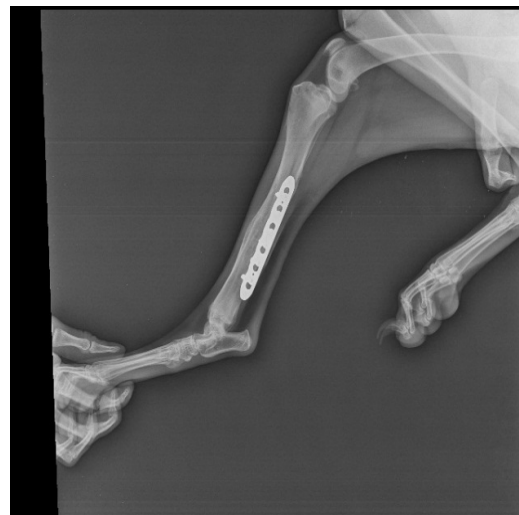
Fig. 8: Bx1 is increase as compared to Bx2 due to self mutilating wound exposing the plate outside. Bx1: operated limb, Bx2: normal limb (90th day after surgery)

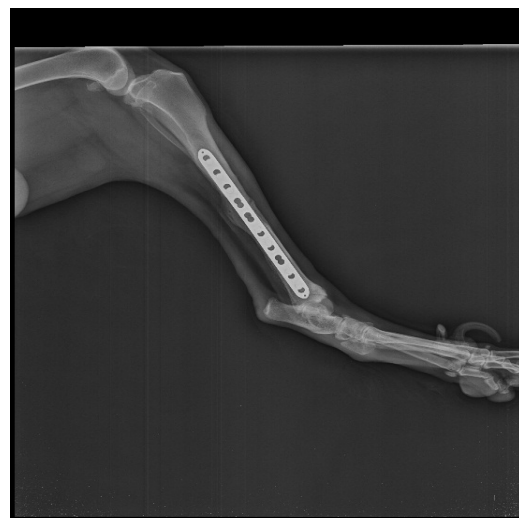
Fig. 9: Bx1 (89.2 °F) is higher than Bx2 (88.1 °F). Bx1: operated limb, Bx2: normal limb (120th post-operative day)
